**LIQUEFACTION EFFECTS AND ASSOCIATED DAMAGE
AT THE PORT OF WELLINGTON**

Version 1.0: 22 JUNE 2017

This is QuakeCoRE publication number 0198 and UC Research Report 2017-8. The content is identical with Chapter 5 of GEER Report Number: GEER-053 and UC Research Report 2017-7.

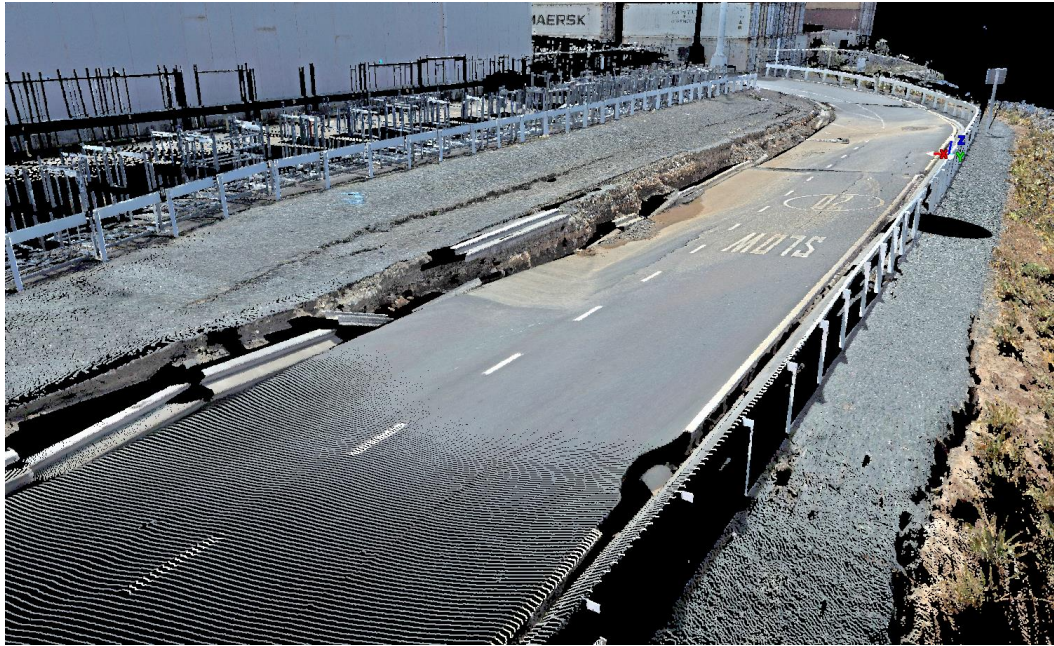
Figure 7.11: LiDAR scan of damage to the asphalt pavement and concrete curbs on the access road located south of the CS building. The vertical offset is approximately 1.1 m. This view is looking to the northeast.

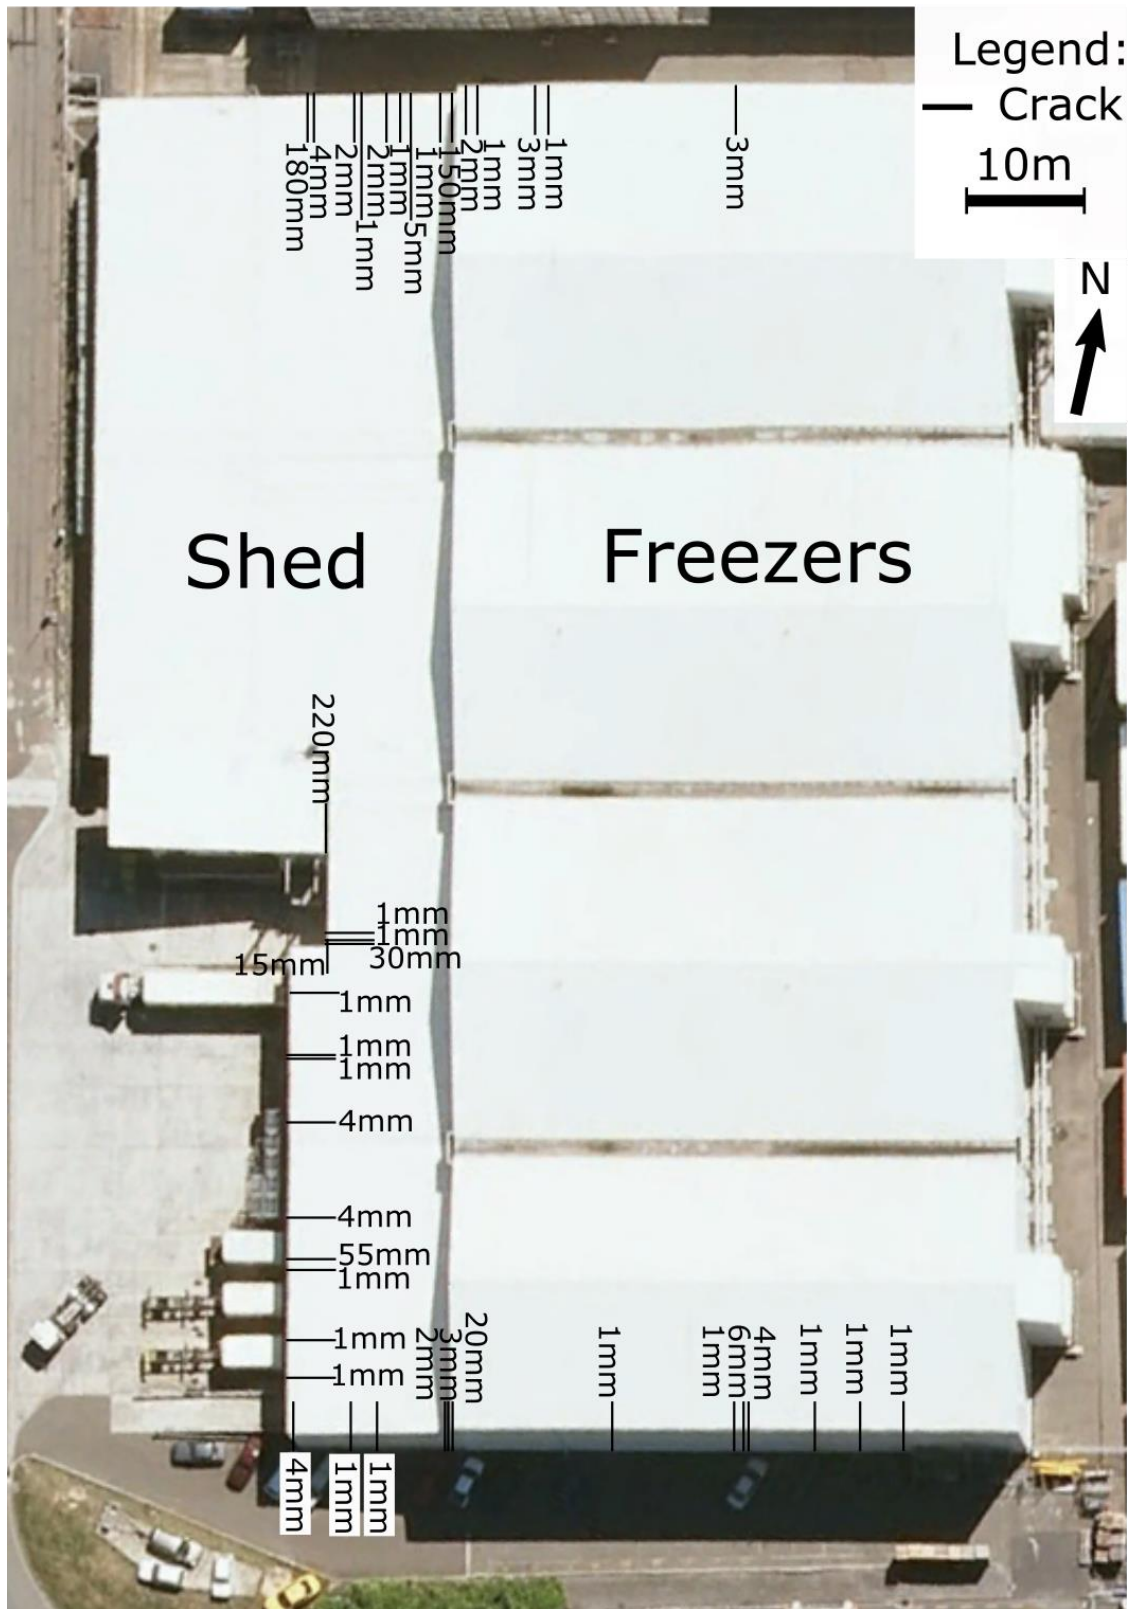
Figure 7.12: Location and width of lateral ground movement-induced cracks in the RC concrete walls at the base of the exterior building walls of the CS building. Crack openings are parallel to each wall.

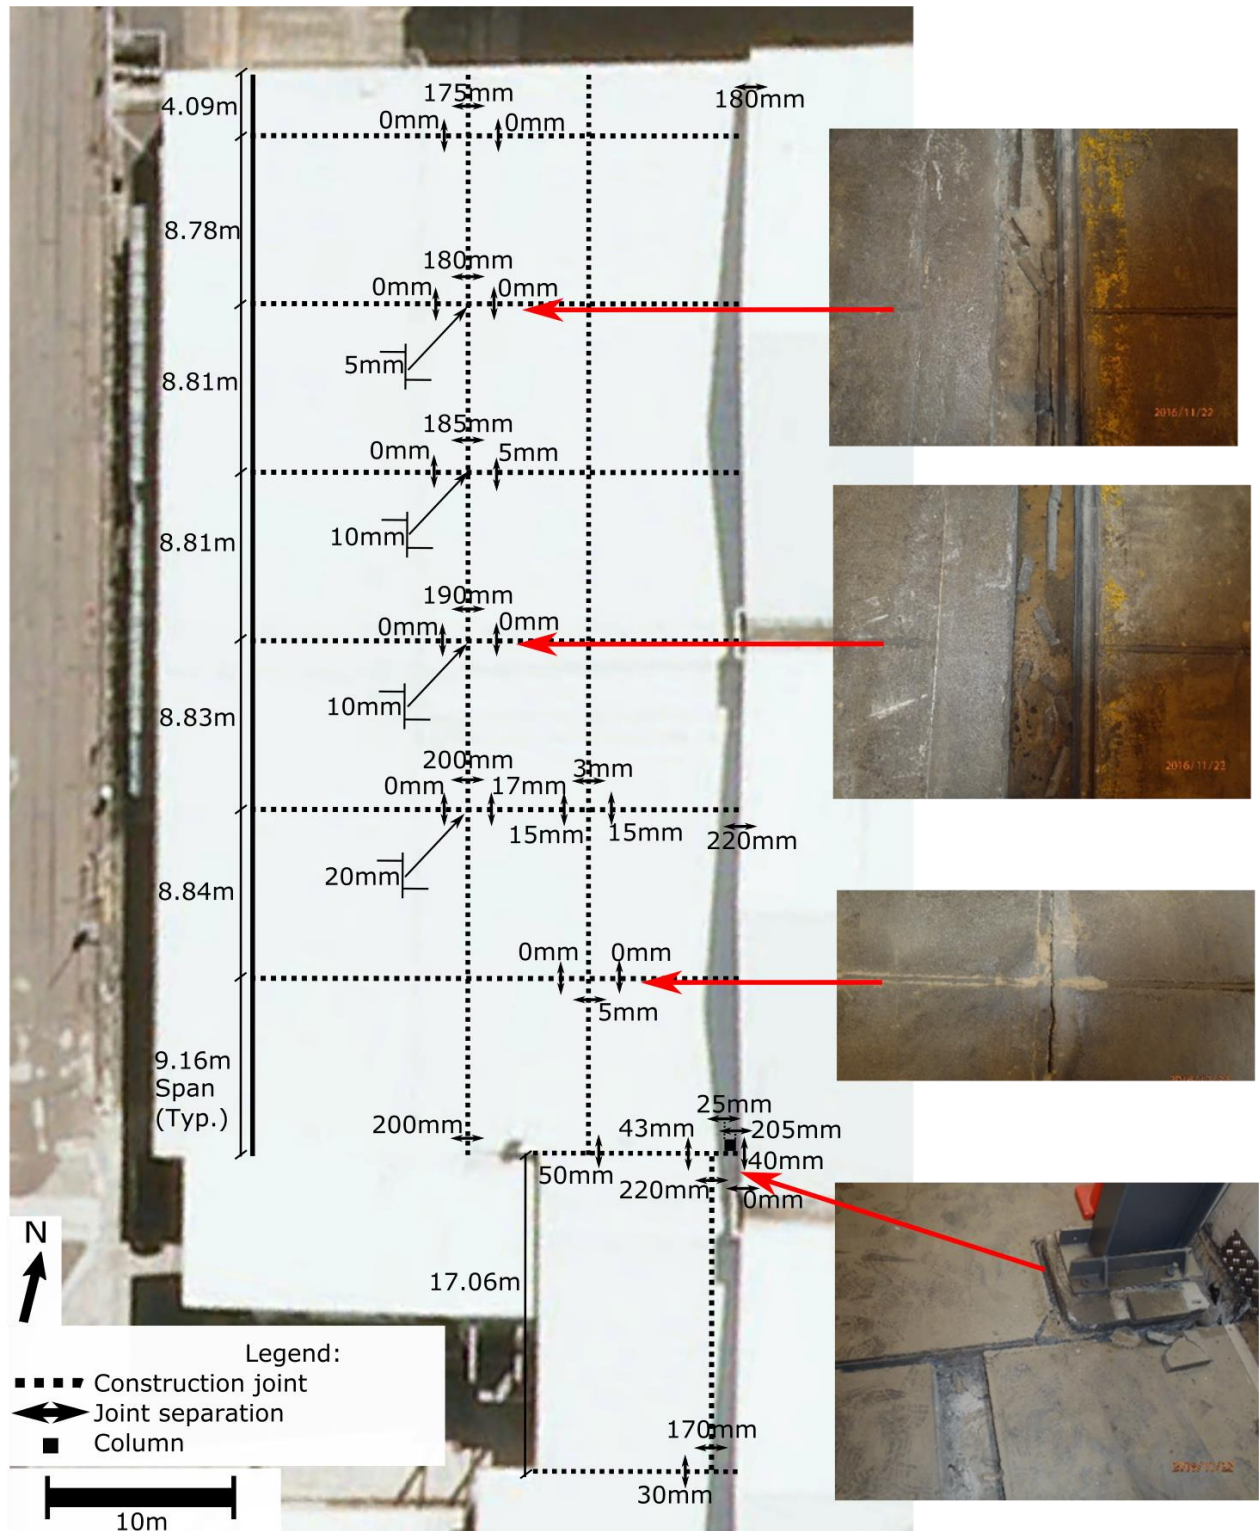
Figure 7.15: Northern part of Shed floor slab contraction joint separation measurements. Photographs along right side of figure are of contraction joints at which measurements were taken and are aligned vertically with each depicted joint. (Taken 22NOV16)

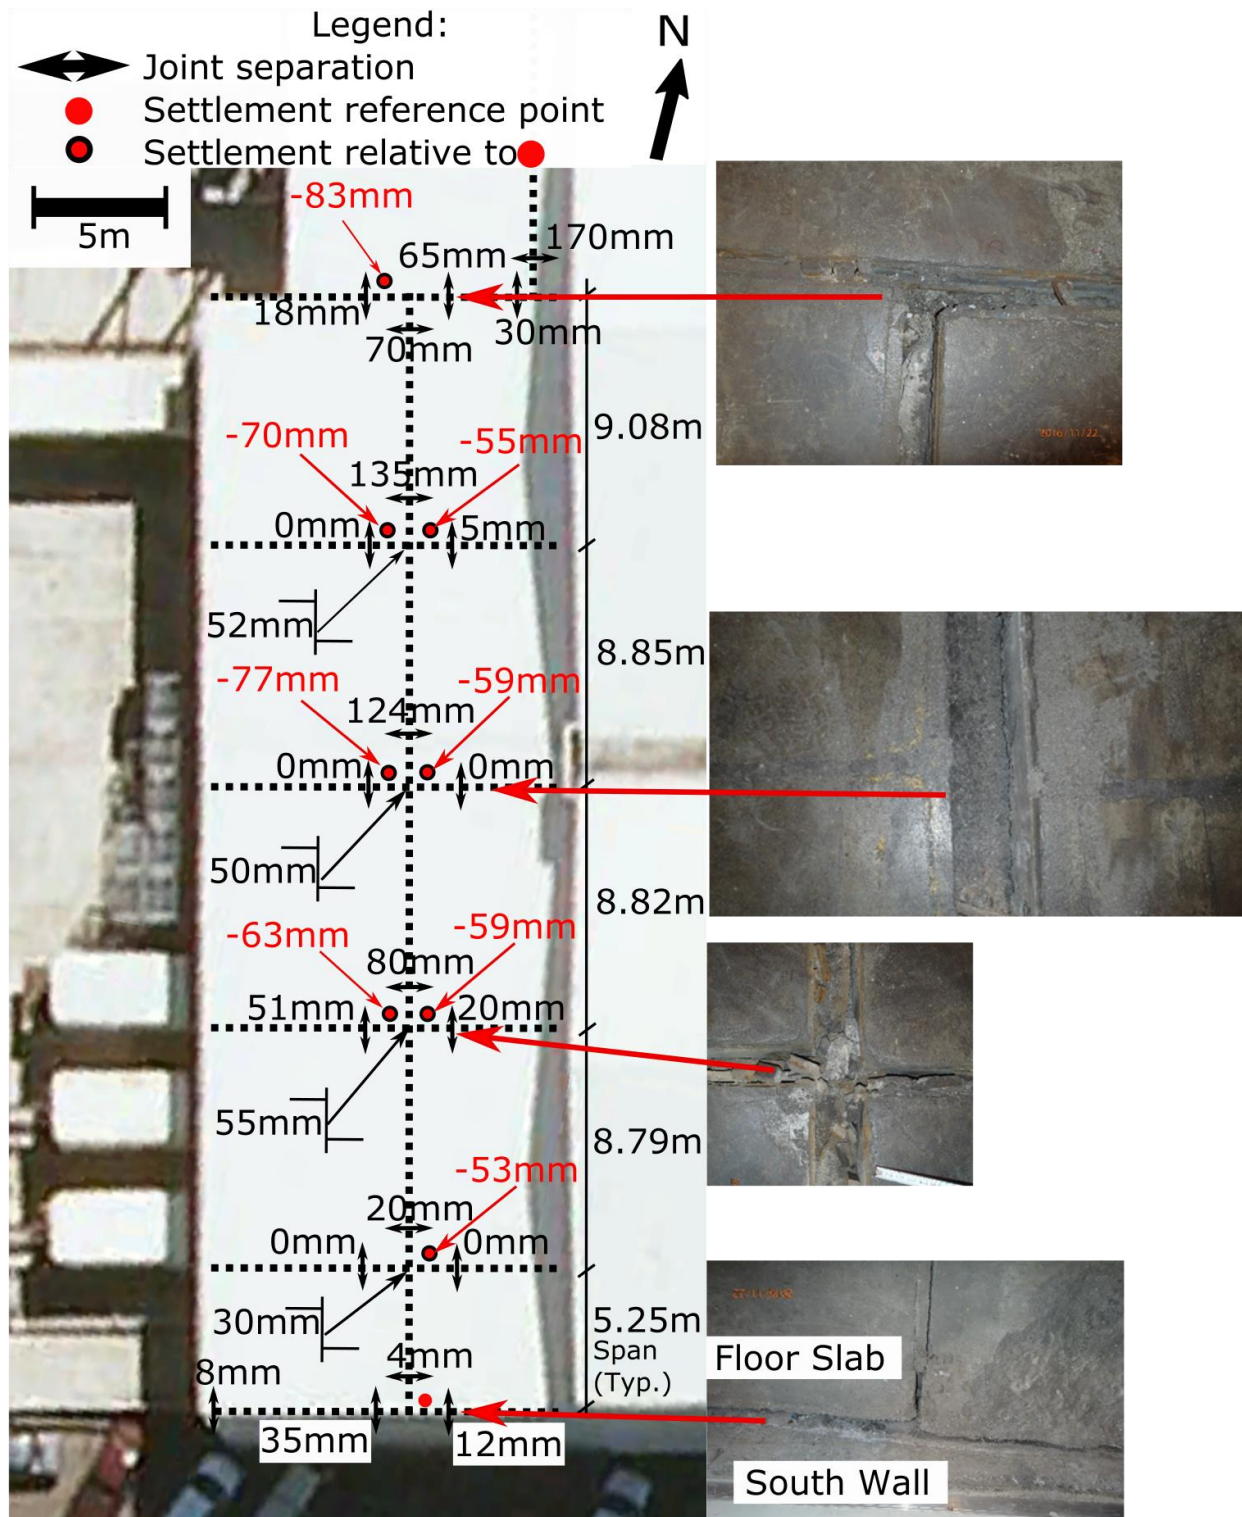
Figure 7.16: Southern part of Shed floor slab contraction joint separation measurements. Photographs along right side of figure are of contraction joints at which measurements were taken and are aligned vertically with each depicted joint. (Taken 22NOV16)

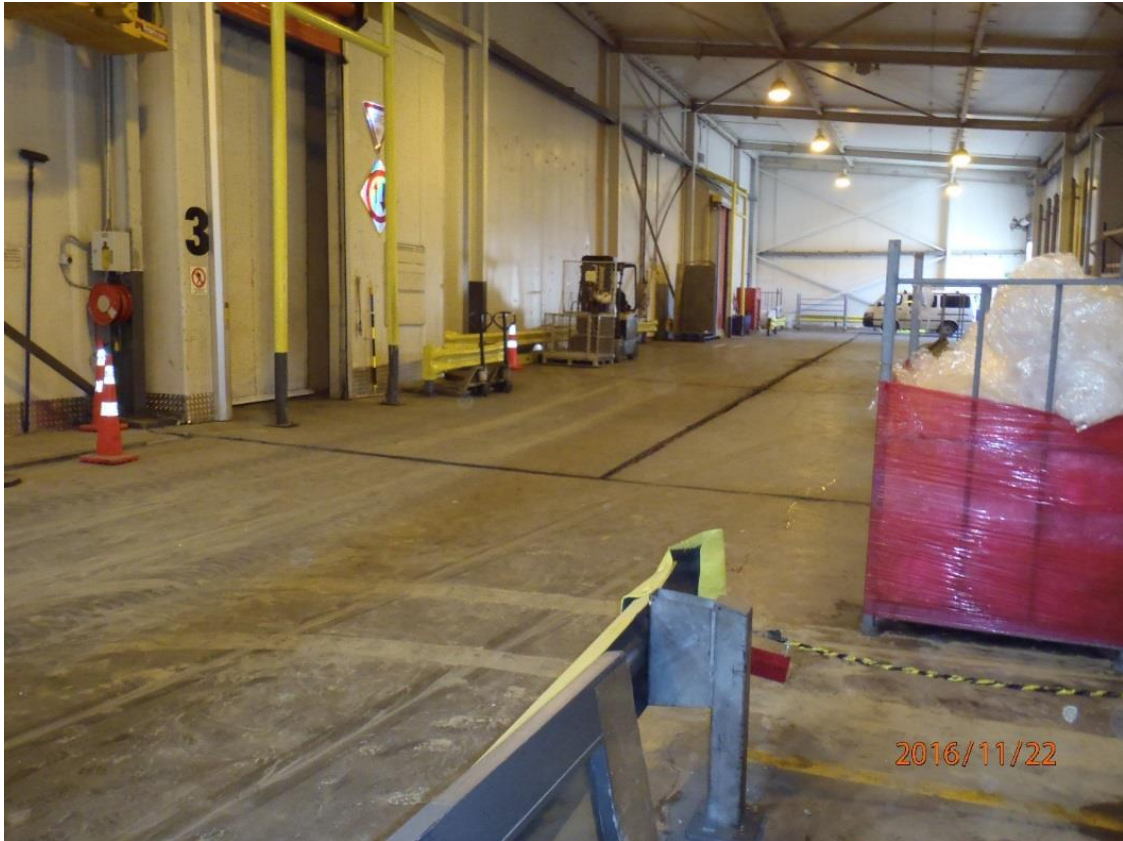
Figure 7.17: Contraction joint separation of ground floor slab inside the Shed of CS building looking south. As shown in photo, joint separations occurred in two orthogonal directions. (S41.281255° E174.784797°, taken at 1520 hrs on 22NOV16)

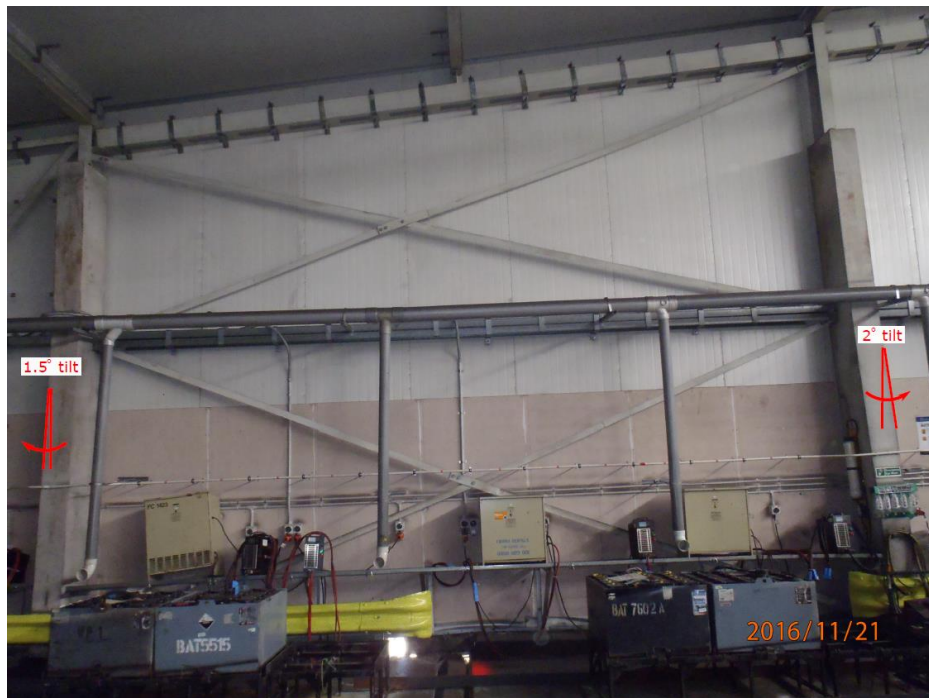
Figure 7.19: Internal north wall of Shed of CS building showing 1.5° clockwise tilt of the left column (2nd column from the west along north wall), and 2° counterclockwise tilt of the right column (3rd column from the west along north wall). This deformation was caused by a 180 mm opening in the RC base wall, which is visible in the bottom middle of the photograph where light is entering building. This column span is 8.789 m from centerline of column to centerline at a height of 1.5 m above the floor slab. (S41.280626° W174.784450°, taken at 1452 hrs on 21NOV16)

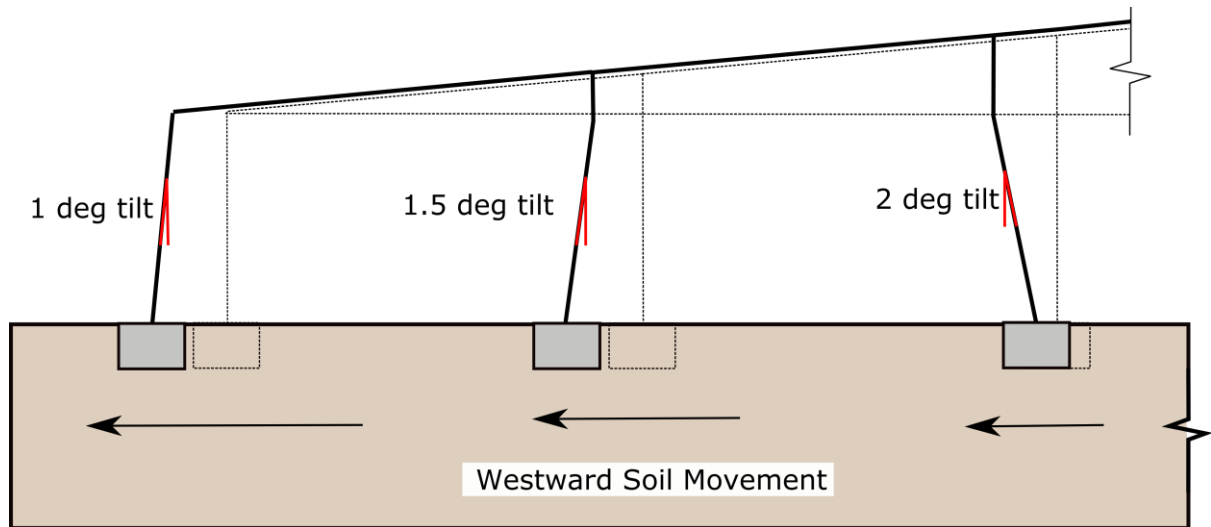
Figure 7.20: Schematic of deformation pattern of steel frame along the north wall of CS building (3 west-most columns of the Shed; looking north from interior).

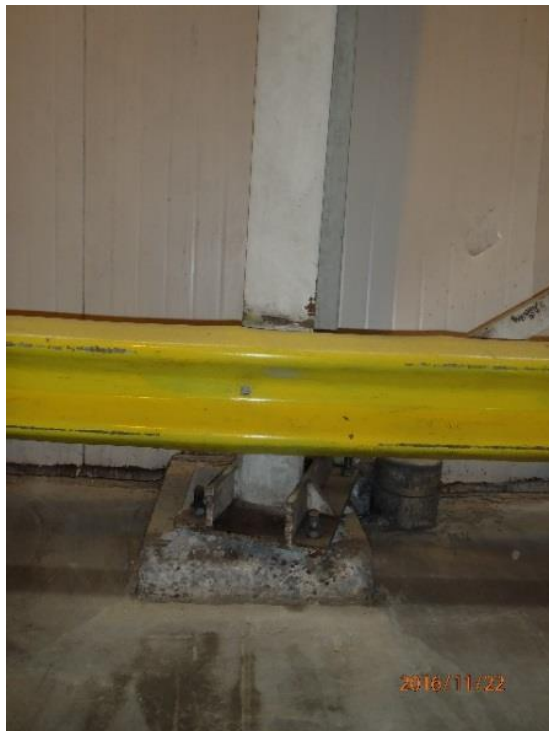
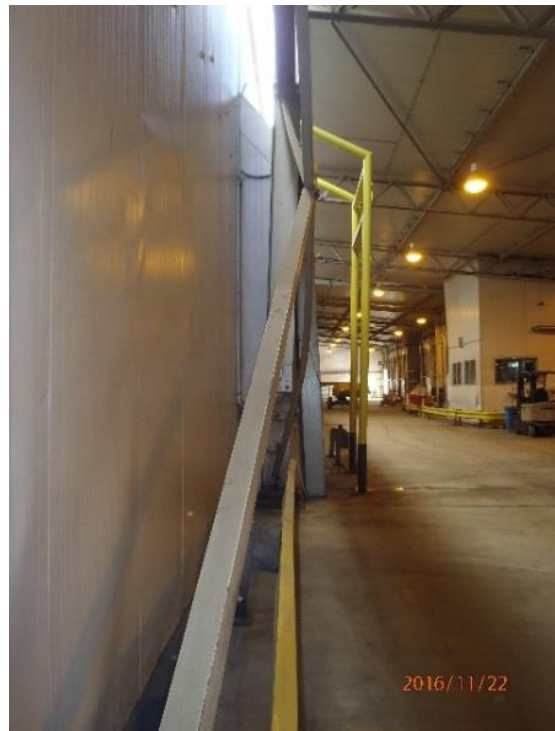
Figure 7.21: Internal east wall in northern part of the Shed, which shows column-pedestal connection failure due to rotation of the base of the column and buckling of concentric bracing. (Approx. at S41.280939° E174.784778°, taken at 1615 hrs on 22NOV16)

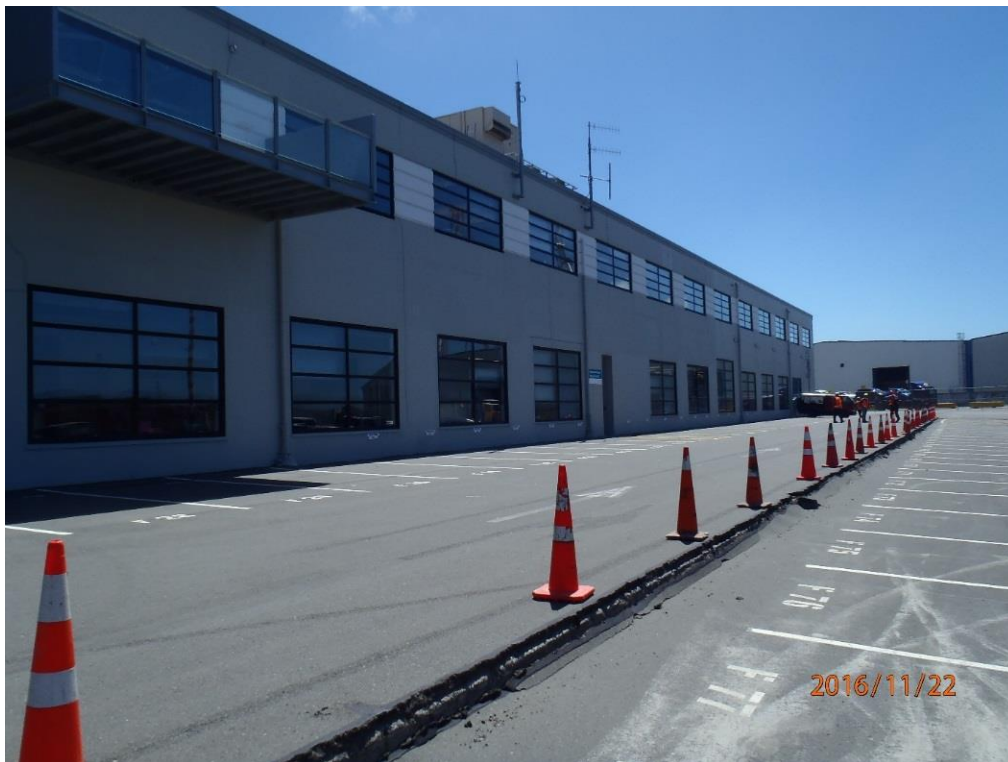
Figure 7.22: Southeast side of Building S39 and a buried segment of the Fryatt Quay Wharf deck parallel to the building. Fill to the south of the buried mass concrete seawall/wharf settled 220 mm relative to the pile-supported building and wharf deck. (S41.277984°, E174.785776°, taken at 1230 hrs on 22NOV16)

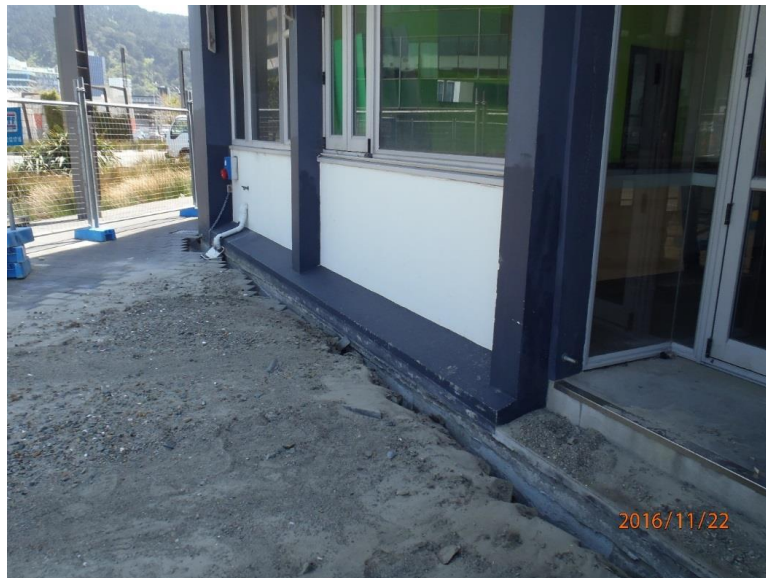
Figure 7.25: Southwest wall of TC building with liquefaction ejecta and 150 mm of ground settlement relative to building. (S41.277858°, E174.785081°, taken at 1246 hrs on 22NOV16)

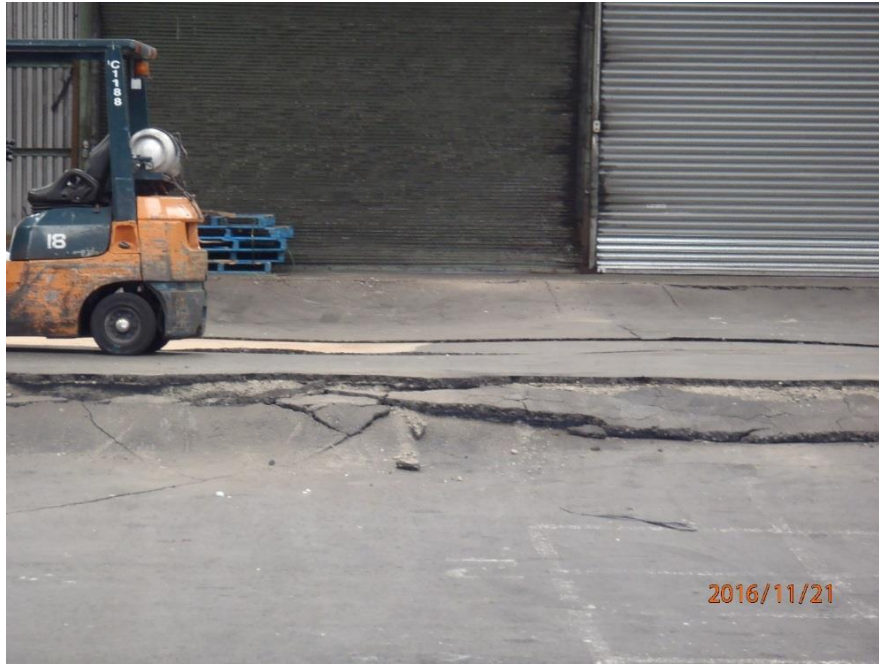
Figure 7.26: Looking west across inside of the S37 building. Approximately 400-550 mm of differential settlement between the ground and the buried precast concrete seawall that runs south-to-north through the center of the building. (S41.279065°, E174.785787°, taken at 1220 hrs on 21NOV16)

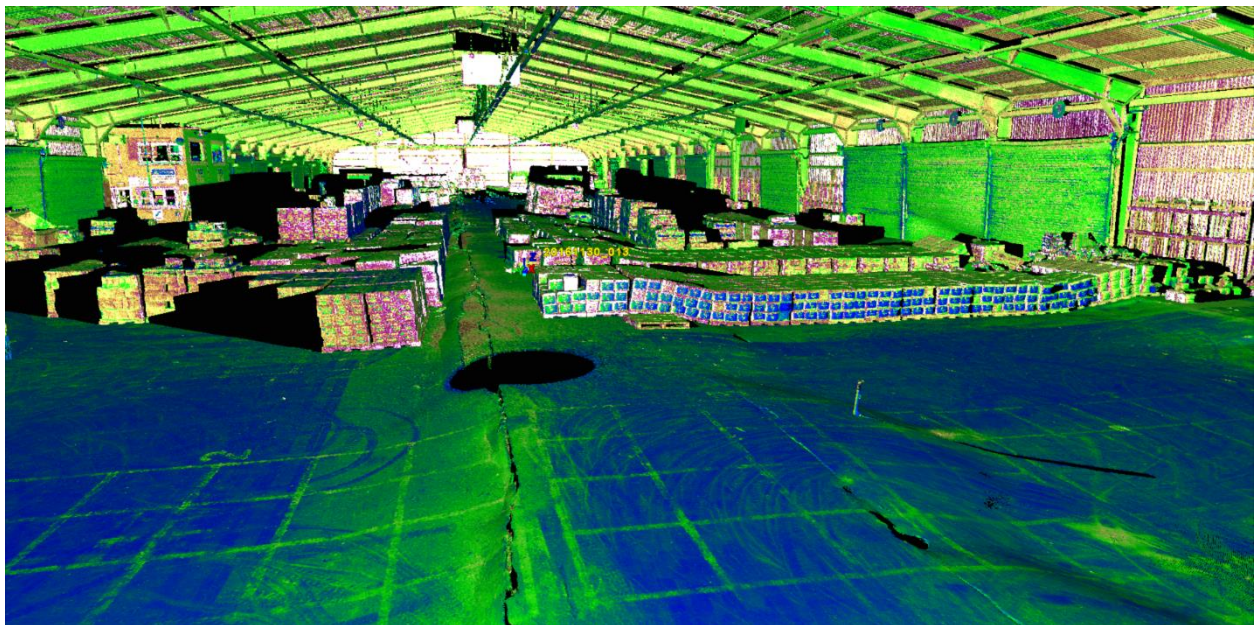
Figure 7.29: LiDAR scan obtained inside Building S37 showing cracking and settlement of the pavement around the buried precast concrete seawall (up to 550 mm of differential settlement occurred).

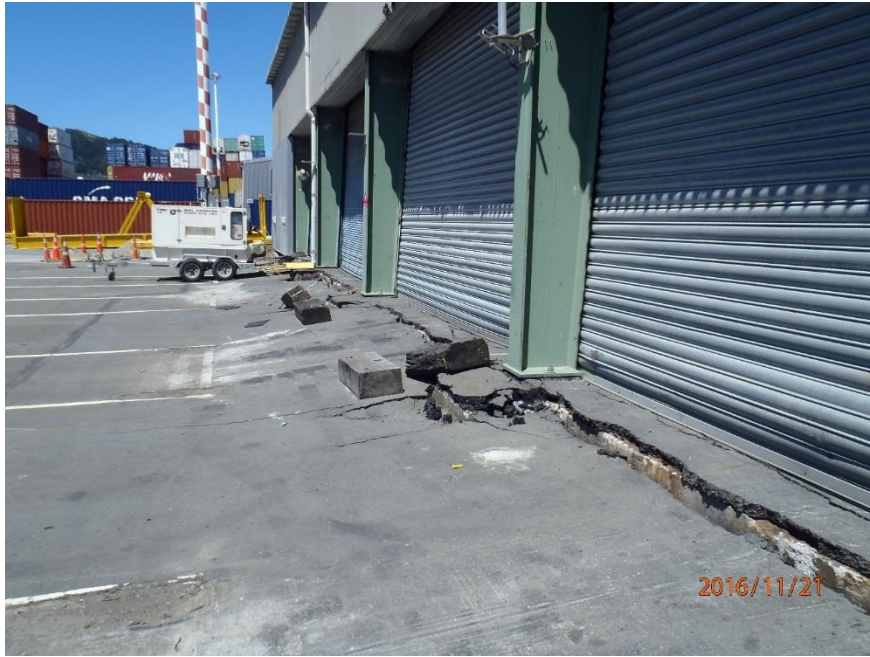
Figure 7.30: Looking south along east wall of Building S37, which shows approximately 375 mm of differential settlement between fill and pile-supported east wall of the building. (S41.279065°, E174.785787°, taken at 1220 hrs on 21NOV16)

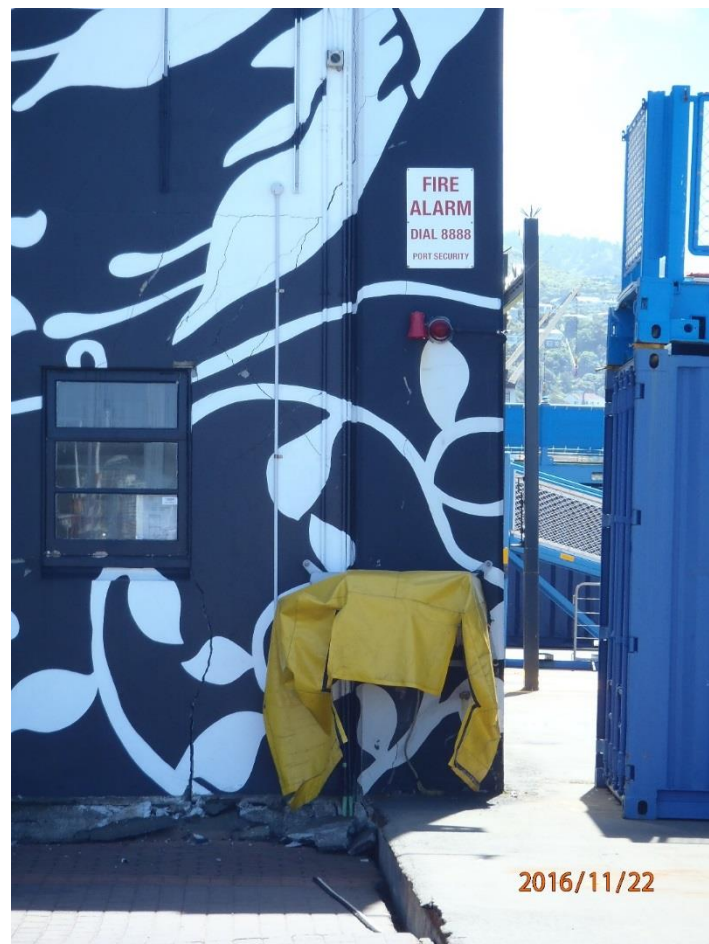
Figure 7.32: Southeast corner of Building S51 looking north, which shows 230 mm of differential settlement between wharf that supports its east wall and the inland fill. Also visible is 35 mm crack from seaward movement of wharf relative to adjacent ground. (S41.272404°, E174.787815°, taken at 1303 hrs on 22NOV16)

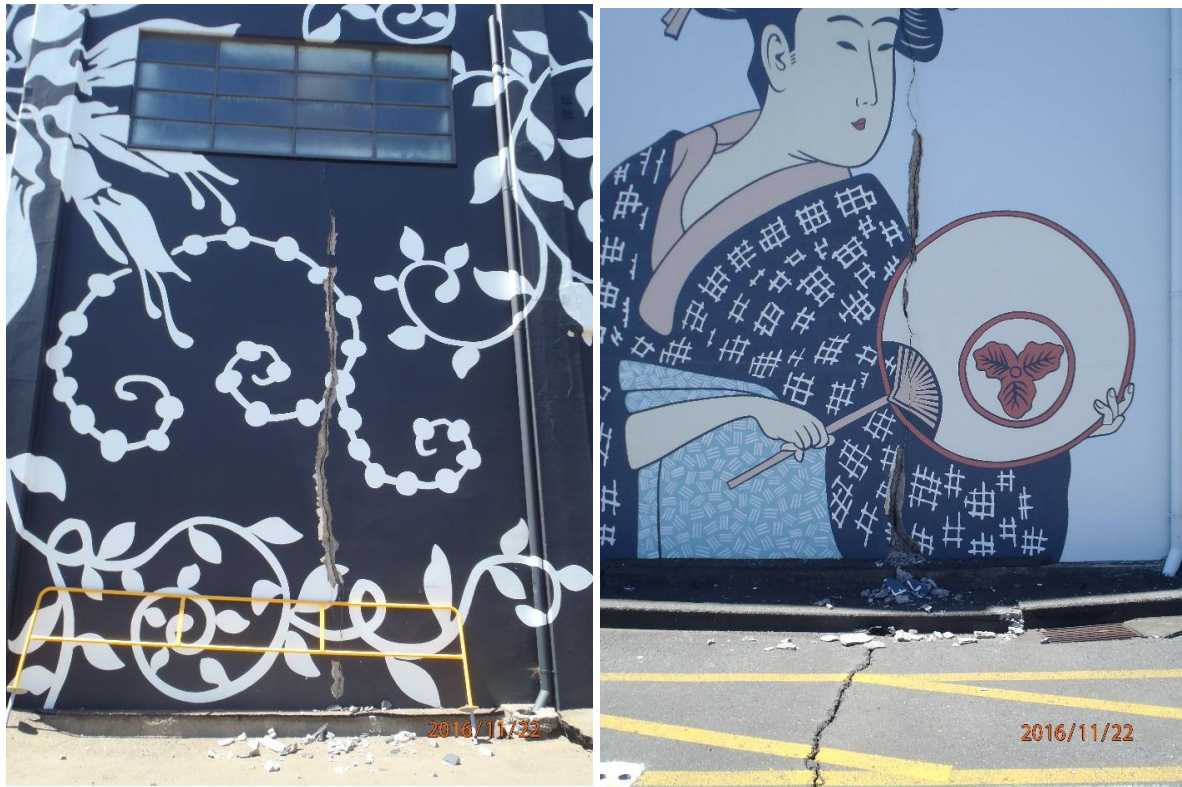
Figure 7.33: Vertical cracks along exterior west wall of S51 located at approximately 25 meters (left photo), and 60 meters (right photo) north of the southwest building corner. (Left: S41.272224°, E174.787391°, taken at 1316 hrs on 22NOV16. Right: S41.271906°, E174.787307°, taken at 1312 hrs on 22NOV16)

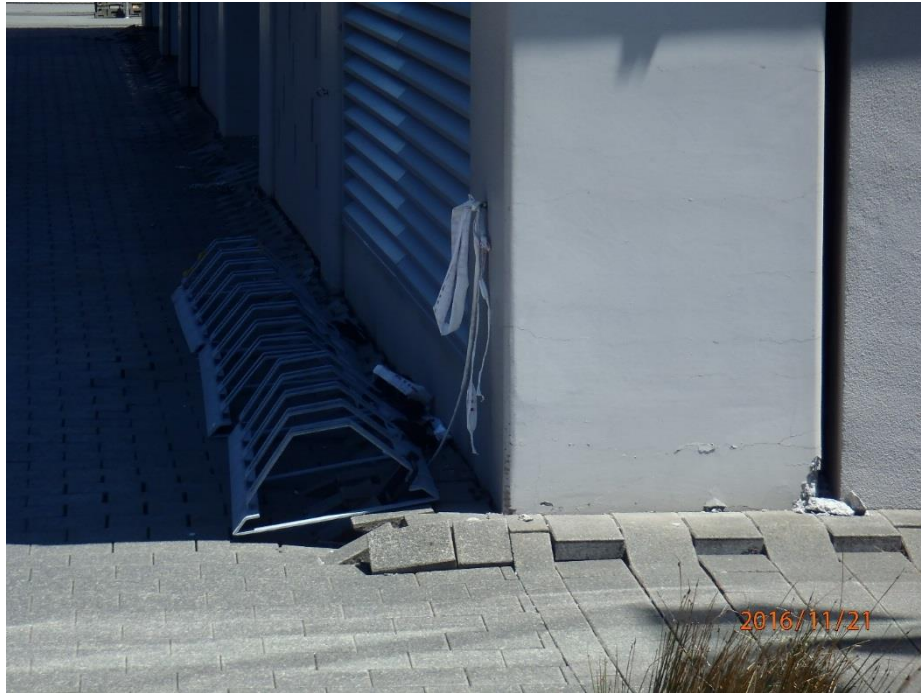
Figure 7.34: Looking west at southeast corner of the S building at which fill settled approximately 100 to 200 mm relative to pile-supported building. (S41.278285°, E174.784757°, taken at 1243 hrs on 21NOV16)

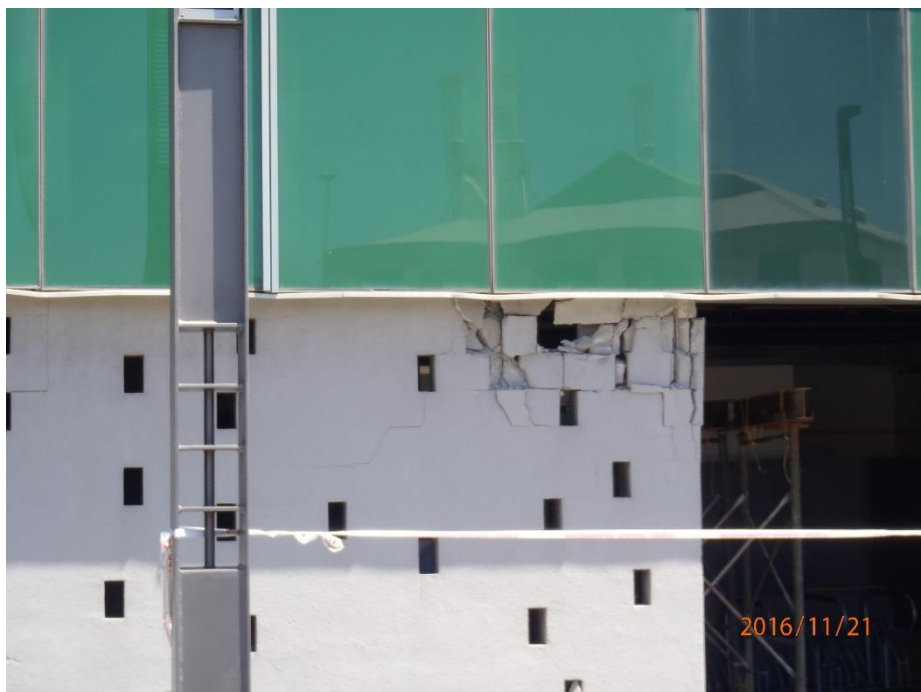
Figure 7.35: Damage to ground floor infill wall on the east side of the S building (S41.278114°, E174.784715°, 1241 hrs on 21NOV16)

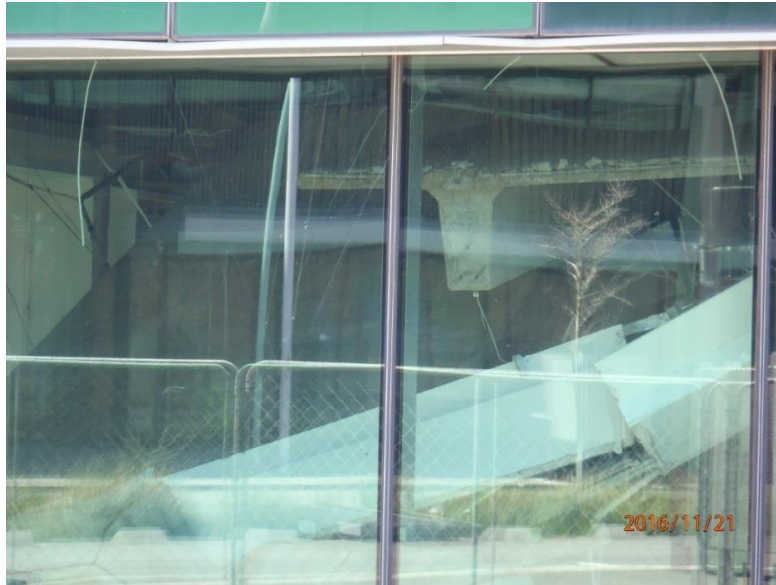
Figure 7.36: Pull-out and partial collapse of Level 1 floor slab in the S building taken along the west wall of the building. (S41.277982°, E174.784255°, taken at 1246 hrs on 21NOV16)
